# Information and recommendations for inspection and use of TRAC AND TRAC PLUS pulleys

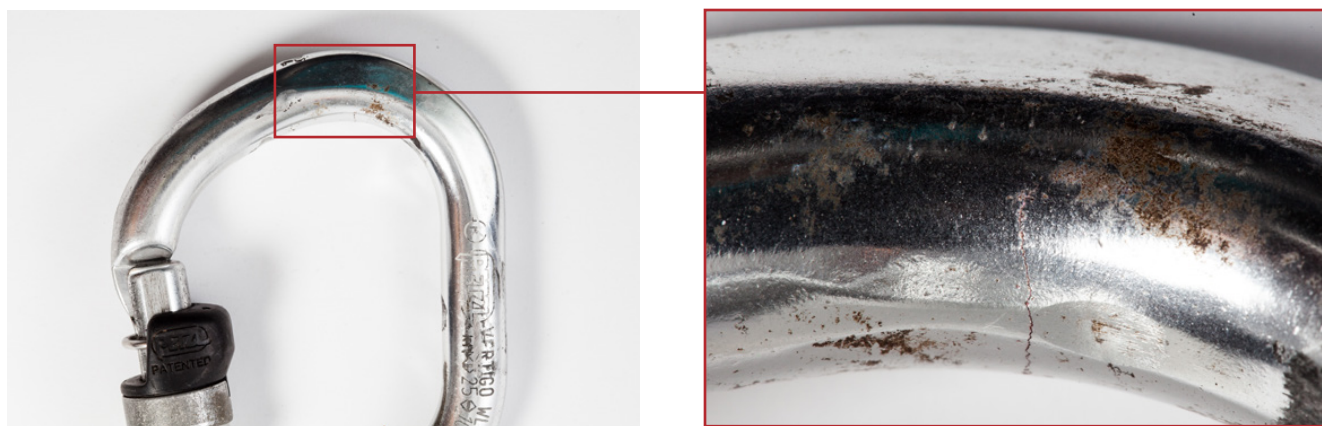
three adventure parks that operate zip lines have informed us of cases where a VERTIGO carabiner broke on the TRAC and TRAC PLUS pulleys. Thankfully, there were no injuries in any of these cases. Metallurgical analyses have shown that the breakage is caused by a corrosion micro-crack that forms on the surface and spreads very slowly through vibration fatigue in the most stressed part of the carabiner (see photo below). This crack was not detected during repeated PPE inspections, as it is located in the upper part of the carabiner which is hidden by the pulleys' side plates.

According to our analyses, this phenomenon is a result of the combination of two contributing factors:

- a corrosive environment: near the ocean, a stretch of water, etc.
- very intensive use: combining a high frequency of use with a very long zip line produces vibration effects.

- When inspecting your park's PPE, the VERTIGO carabiner should always be removed from the TRAC and TRAC PLUS pulleys to allow for a complete and detailed inspection. As outlined in the PPE inspection procedure, any crack found on a carabiner indicates that it must be immediately retired. The PPE inspection sheet for TRAC and TRAC PLUS pulleys is available in attachment.

- Adapt the frequency of TRAC and TRAC PLUS pulley PPE inspections to the intensity of use, according to the following table:

Dry environment	Humid environment
Distance traveled $\leq$ 2 km/day	3 months	2 months
Distance traveled $\geq$ 2 km/day	2 months	1 month

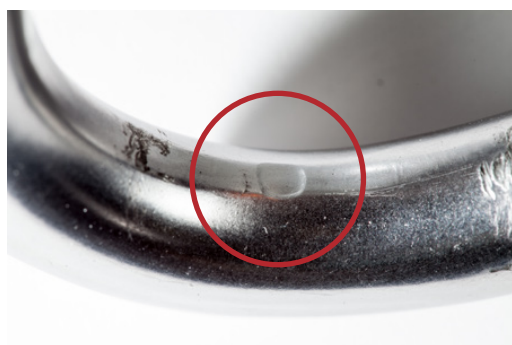
Visible marks on the inside of the VERTIGO frame are caused by our individual tensile tests. We perform these tests on every single Petzl carabiner. These marks are not the cause of the corrosion cracking. These marks are very close to the most stressed section of the carabiner when it is used in the TRAC or TRAC PLUS. This is normal - the individual tensile test is designed to reflect the use.
