# Information and recommendations for inspection and use of TRAC AND TRAC PLUS pulleys

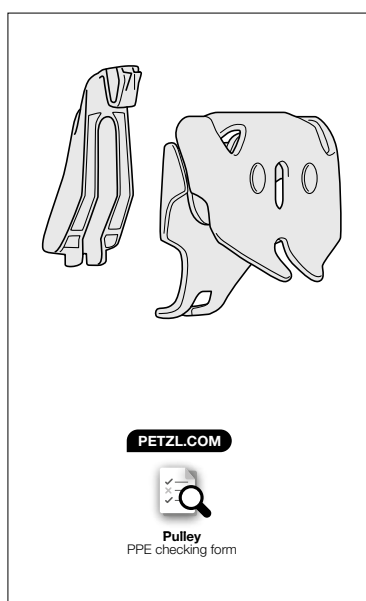
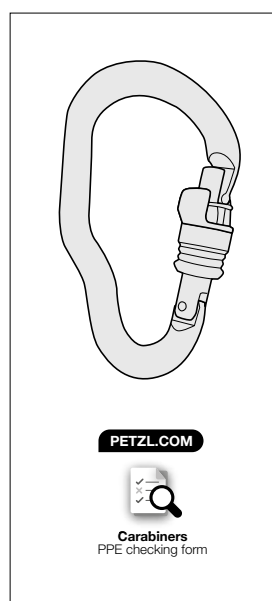
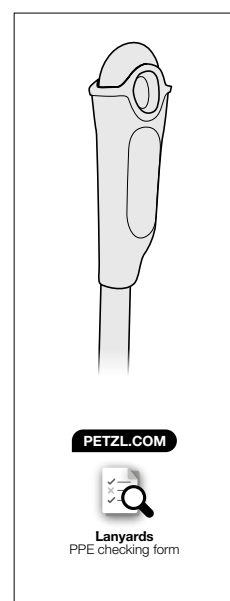
For a complete PPE inspection of your TRAC or TRAC PLUS, make sure to disassemble it to be able to check properly every part.

- When inspecting your park's PPE, the VERTIGO carabiner should always be removed from the TRAC and TRAC PLUS pulleys to allow for a complete and detailed inspection. As outlined in the PPE inspection procedure, any crack found on a carabiner indicates that it must be immediately retired. The PPE inspection sheet for TRAC and TRAC PLUS pulleys is available in attachment.
